# SAFETY IS NO ACCIDENT

## Zenith's aircraft are high-utility contenders. So how's their record?

BY RON WANTTAJA

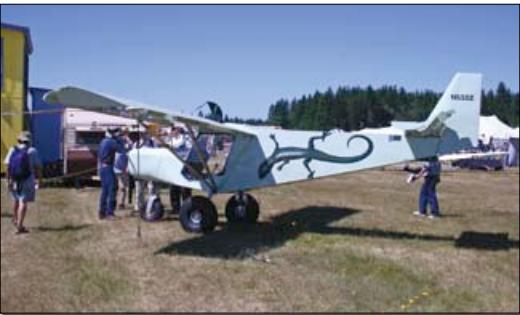
CH 701 builders often enhance their airplanes' bush capabilities by using large wheels and tires. These high-drag items can result in a steeper descent rate.

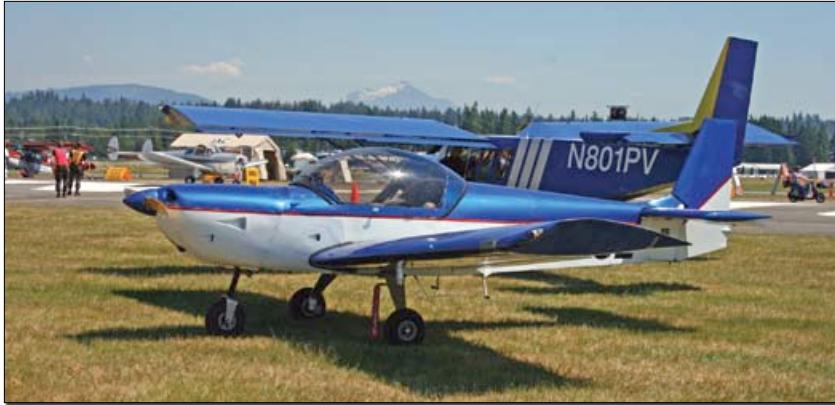
The CH 601 series has used a variety of engines. This example mounts a Corvair auto-engine conversion.

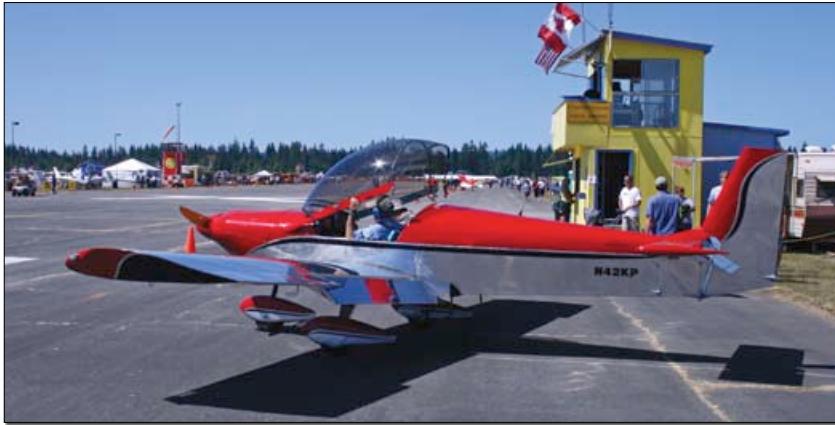
The CH 601 XL series' reputation was tarnished somewhat by a number of wing-failure accidents recently. The company has responded with a set of modifications.
